PIC18F87J10 Family Rev. A4 Silicon Errata

The PIC18F87J10 family parts you have received conform functionally to the Device Data Sheet (DS39663F), except for the anomalies described below. Any Data Sheet Clarification issues related to the PIC18F87J10 family will be reported in a separate Data Sheet errata. Please check the Microchip web site for any existing issues.

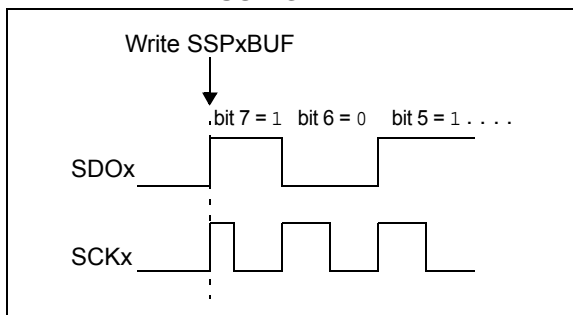
FIGURE 1: SCKx PULSE VARIATION USING TIMER2/2

When the SPI is using Timer2/2 as the clock source, a shorter than expected SCKx pulse may occur on the first bit of the transmitted/received data (see Figure 1).

To avoid producing the short pulse:

1. Turn off Timer2.
2. Clear the TMR2 register.
3. Load the SSPxBUF with the data to be transmitted.
4. Turn Timer2 back on.
