MICROCHIP PIC32MX1XX/2XX 28/44-PIN XLP

PIC32MX1XX/2XX 28/44-pin XLP Family Silicon Errata and Data Sheet Clarification

The PIC32MX1XX/2XX 28/44-pin XLP family devices that you have received conform functionally to the current Device Data Sheet (DS60001404B), except for the anomalies described in this document.

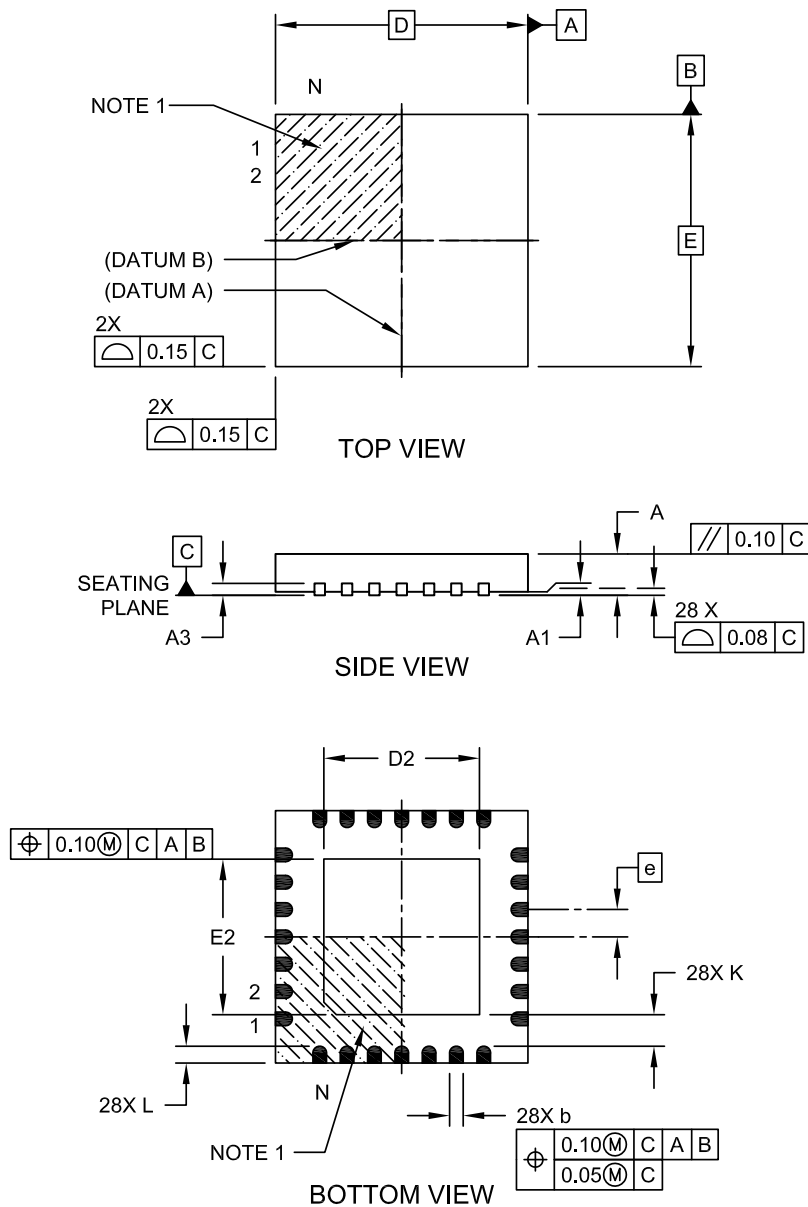
FIGURE 1:

In the current data sheet, incorrect packaging information was provided for the 28-Lead QFN-S package. [Figure 1](#) through [Figure 3](#) show the correct package drawings and land pattern.

28-Lead Plastic Quad Flat, No Lead Package (MM) - 6x6x0.9mm Body [QFN-S] With 0.40 mm Terminal Length

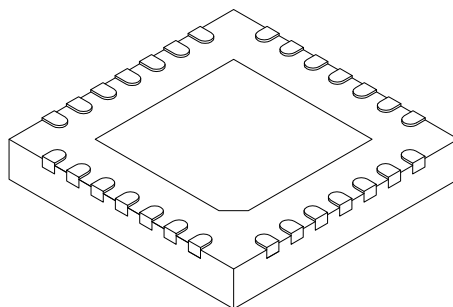
FIGURE 2:

28-Lead Plastic Quad Flat, No Lead Package (MM) - 6x6x0.9mm Body [QFN-S] With 0.40 mm Terminal Length

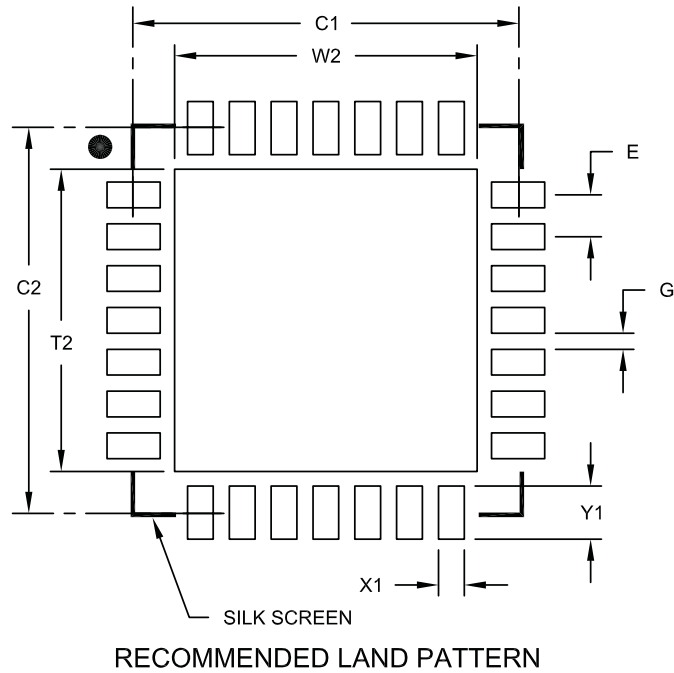
28-Lead Plastic Quad Flat, No Lead Package (MM) – 6x6x0.9 mm Body [QFN-S]
with 0.40 mm Contact Length
